**Town of South Hadley
Self-Evaluation and Transition Plan
October 2019**

**TOWN OF SOUTH HADLEY – SELF-EVALUATION AND TRANSITION PLAN
TABLE OF CONTENTS**

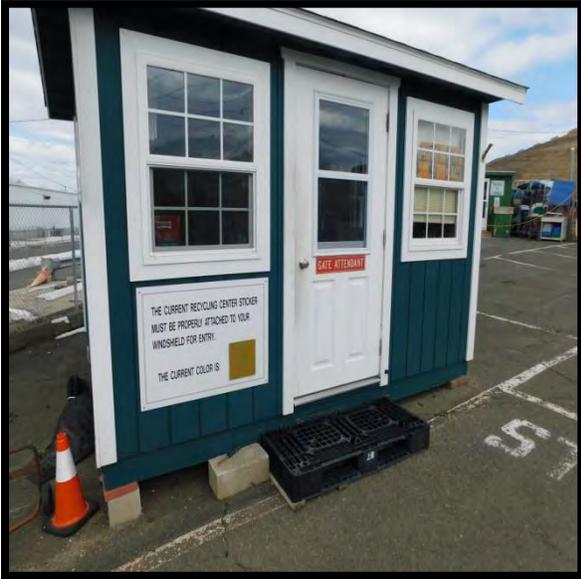
Photo Transfer Station 1

General Description or Obstacle Which Limits Mobility or Access: There is no designated accessible parking. There is no accessible route of travel to the various bins and buildings. Most of the buildings have either excessive changes in level surface from the ground to the floor level of the building or access is achieved through the use of non-compliant stairs and railings or non-compliant ramps. The clothing drop bins exceed maximum reach range under the 2010 ADA Standards.
