**Town of South Hadley
Self-Evaluation and Transition Plan
October 2019**

**TOWN OF SOUTH HADLEY – SELF-EVALUATION AND TRANSITION PLAN
TABLE OF CONTENTS**

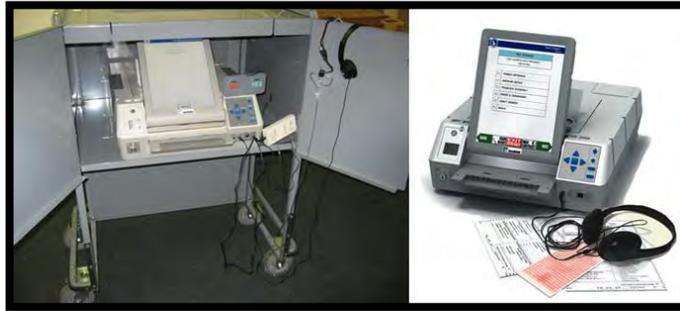
There is also an AutoMARK Voter Assist Terminal; an optical scan ballot marker designed for use by people who are unable to personally mark an optical scan ballot due to physical, visual impairments or language barriers is placed where the display screen is not visible to the voting public. This is so important because there are numerous cases where the AutoMARK is placed alongside the other voting booths and the screen is in full view of voters passing by. This violates voter privacy. Below are some visual examples of the AutoMARK terminal.

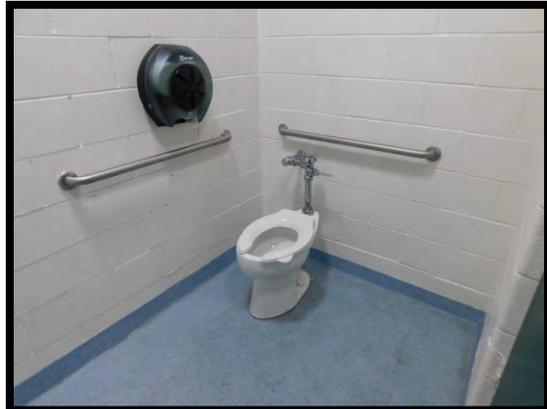
Photo Beachgrounds 6

Women's Bathroom Only							
The sink piping is not wrapped, guarded, or insulated	606.5	30.9.5	Wrap or insulate piping.	3	2	I	\$50
The towel dispenser is 42" a.f.f. and protrudes 9½" into the accessible route of travel which exceeds that allowed as a protrusion by 5½".	307.2	20.6.1	Place a fixed object under the towel dispenser.	3	1	I	\$0
Men's Bathroom Only							
The grab bars are 6" too short.	604.5	30.8	Replace existing grab bars with grab bars that are 42" long.	3	2	I	\$250
The rear and grab bars are both mounted 1" too far from the inside corner.	604.5 609.4	30.8.1	The rear grab s/b mounted no more than 6" from the interior corner and the side grab bar s/b mounted no more than 12" from the interior corner.	3	2	I	\$0
See Photos Beachgrounds 6.

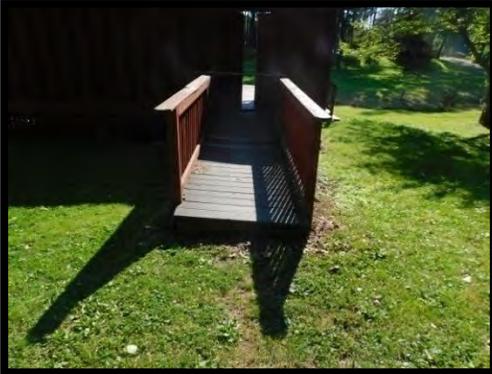
Photo Buttery Brook 15

The <u>bottom tread</u> is not uniform as it is on concrete with a 2" to 4" gap or reveal of concrete creating a potential tripping hazard. See Photo Buttery Brook 15.	504.2	27.2	Modify the bottom tread on both sides of the stairs so that the tread covers the entire concrete pad.	1	3	N	\$150
There is a 6" abrupt change in level surface to access the <u>ramp</u> and a 3" abrupt change in level surface to access the stage from the ramp. <u>Railings</u> are not paired, are not compliant as to shape and size, and do not extend at the bottom. There is <u>no level landing</u> at the ramp top at the stage doorway entry. The ramp is <u>warped</u> at the top. The ramp is only 42" <u>wide</u> which is at least 6" too narrow (depending on railing placement) under 521 CMR. See Photos Buttery Brook 16 and 17.	405 505	24	Remove the existing ramp and construct a new ramp that complies with the following: Running slopes no greater 8.3% r.s.; cross slopes no greater than 2.0%; paired railings (34" to 38" a.f.f. top, 18" to 20" a.f.f. bottom); top and bottom 12" railing extensions; minimum 48" clear width between the railings (521 CMR); railings must be oval or round in shape with an outside diameter of 1½" to 2"; a 60" level landing must be provided at the top; and edge protection on the ramp sides.	1	3	N	Up to \$25,000

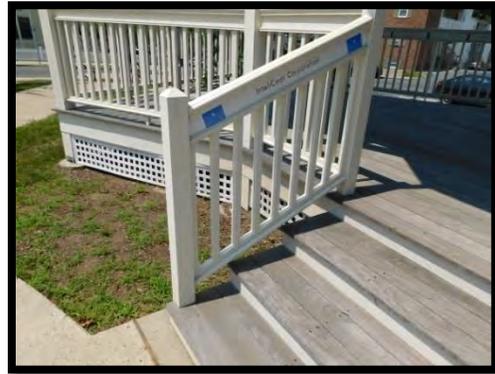
The <u>gazebo stair tread nosings</u> are not curved or beveled and have a greater than ½" projection. See Photo Town Common 2 .	504.5	27.3	Stair treads must be modified by either reducing the projection to less than ½" or beveling the nosing.	1	3	N	\$750+
The <u>gazebo ramp railings</u> vary from 20" a.f.f. at the bottom railing to 33" a.f.f. at the top railing. <u>Note:</u> No tolerances allowed for dimensions within a stated range.	405.8 505	24.5	Modify/adjust/replace railings to comply with 18"-20" a.f.f. (bottom) and 34"-38" a.f.f. (top) height ranges to the top of the handrail.	1	3	N	Up to \$5,000
There is an abrupt change in level surface of roughly ½" at the top of the <u>concrete ramp</u> to the gazebo decking. See Photo Town Common 3 .	403.4 405	22.4 24	Modify and bevel the decking or use a flexible or bonding material to create a beveled approach within the gap between the concrete and decking or a combination of the two.	1	3	N	Up to \$250

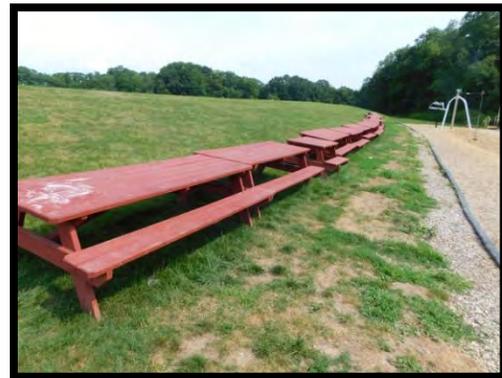
Picnic Tables The picnic tables at the playground and basketball court do not provide the required accessible knee and toe clearance. See Photo MES 2 .	226.1 902	19.5.2 19.6.2	At least 5% or at least one table must be accessible. Replace one table or provide an additional one which has a table surface of between 28" to 34" a.f.f. to the top surface with at least 27" knee clearance, 30" clear width, and 19" depth. The picnic table must be located on an accessible route of travel.	2	1	N	\$750
Accessible Route to Ball Fields/ Playground No accessible route exists to the soccer fields and around the playground perimeter. See Photos MES 3, 4, and 5 .	402 303 403.3 403.4	19.0 20.0 22.4	Construct an accessible route to the to the soccer fields and fully around the playground perimeter with width (4' minimum), slope (2% cross, 5% running), and level surface change requirements (no greater than ¼"). <i>Note: Due to the terrain and elevation differential to access all 3 soccer fields, feasibility and design work may be required to best determine means, methods, and costs to these fields. Options could include vehicle access, switchback ramps with railings or a combination of both coupled with accessible routes around each field. Costs will vary substantially but could approach \$250,000.</i>	1	3	L	TBD Up to \$260,000+

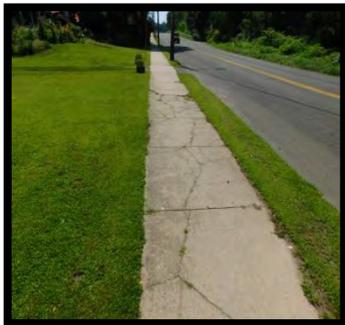
Photo Sidewalks 1

a number of street intersections involve non-compliant curb ramps and/or crosswalks (described below). The sidewalks in front of Saint Patrick’s Church (roughly 135 lf) have cross slopes that vary up to 5.0% (maximum allowed is 2.0%) as do a portion of sidewalk in front of the Beachgrounds near the entrance to Stoney’s Pub (cross slopes vary from 2.3% to 3.5%). In addition, much of the concrete and asphalt sidewalk on Main Street have severe deterioration as well as abrupt changes in level surface of greater than ¼” due to concrete pads heaving and the placement utility/manhole covers in the sidewalk. A SHELD utility cover at #105 Main Street creates a nearly 1” abrupt change in level surface. Similar utility/manhole covers are found in front of St. Patrick’s Church and two raised and curved (2) Bell Systems manhole covers at 128 – 132 Newton Street create an impediment to access. There are a number of locations where the cross slopes at driveways are well in excess of the maximum allowed 2.0%. This includes the sidewalk at the Beachgrounds access across from Town Hall (6.8% cross slope), Stoney’s Pub (6.7% cross slope), 282-284 Newton Street (12.2% cross slope), and Carey’s Flowers (9.4% cross slope). See Photos Sidewalks 1, 2, 3, 4, 5, and 6.

Asphalt and concrete sidewalks which have deteriorated surfaces; non-compliant cross-slopes; and abrupt changes in level surface due to concrete settling, asphalt heaving, or elevated manhole/utility covers within the accessible route should be reclaimed and resurfaced/reconstructed to meet stable and level surface standards. The transition area to driveways need to maintain a no more than 2.0% cross slope and as a result, may require temporary construction easements on private property to modify driveway slopes so vehicles can still utilize the driveways. Reconstruction should also be done in a manner to prevent further pooling of water and accumulation of debris within the accessible route of travel.

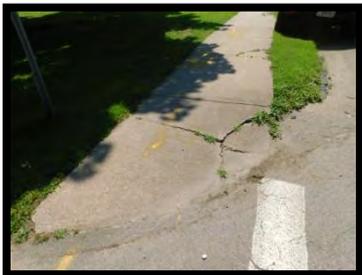
Photo Main Curb Ramps 1

Main Street Area. The curb ramps on Main Street lack detectable warning strips and the cross walks require re-striping. In a number of instances the crosswalk fully or partially ends at a granite curb. In addition, none of the curb ramps have detectable warning strips. The curb ramp at the Pleasant Street cross walk has non-compliant slopes and lacks a compliant level landing. Similar issues exist at the Saint Patrick’s Church crosswalk, Main-Bardwell Street crosswalk changes direction in the street. North Main Street crosswalk, and Main –Carew Street crosswalk. The Bardwell Street crosswalk The Please Street curb ramp serves as an apex ramp, however the intersection geometry does not preclude the use of paired ramps, which are preferred. The curb ramps and crosswalks at the Main Street – Bridge Street intersection has numerous items of non-compliance including excessive running slopes, lack of compliant level landings, lack of detectable warning strips, abrupt changes in level surface, accumulation of debris at the curb ramp base, required re-striping, and a cross walk that changes direction in the street. None of the Accessible Pedestrian Signals at the Main Street - Bridge Street Intersection had audible signalization.

Recommendation: Compliant curb ramps that meet the standards described above should be installed at all locations. The curb ramps at the high school that have level landings that are too narrow may require a “taking” of up to 2 feet to achieve compliant maneuverability.

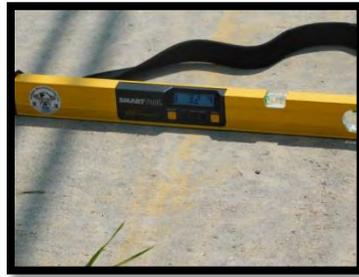
Photo Newton Curb Ramps 2

Newton Street. The curb ramps and cross-walks on Newton Street and Granby Road are in relatively good condition with some exceptions. The Ranger Street curb ramp has an excessive running slope, lacks a compliant level landing, and a manhole in the crosswalk creating an abrupt change in level surface. The Landers Street curb ramp cross slopes at the top of the ramp are excessive as are the running slopes. Curb ramps at the high school (school side near parking lot, at 302-304 Newton Street) lack a compliant level landing as the landings are 18” to 20” too narrow. The curb ramps and crosswalks at the Lyman Street – Newton Street intersection has numerous items of non-compliance including excessive running slopes, lack of compliant level landings, lack of detectable warning strips, and required re-stripping. None of the Accessible Pedestrian Signals at the Lyman Street - Newton Street Intersection had audible signalization. In addition, all of the crosswalks require restriping.

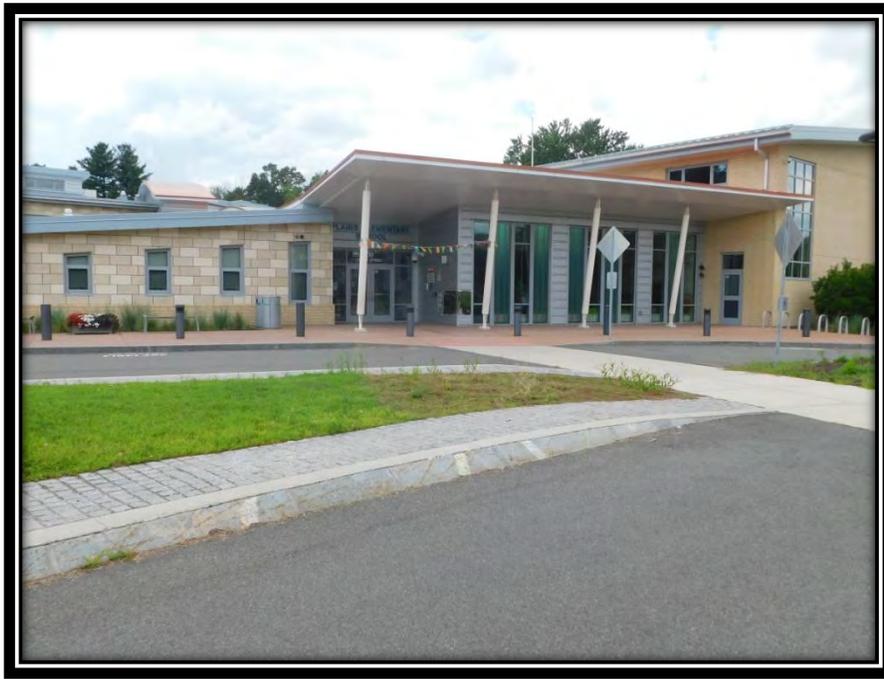
PLAINS ELEMENTARY SCHOOL

General Description or Obstacle Which Limits Mobility or Access: Although substantially compliant as a newer facility, there are still areas of non-compliance at the Plains Elementary School. The signage for the accessible parking is too high. The accessible route between the Lyman Street curb ramp and the main entrance has a concrete segment with a 6.0% to 7.0% running slope. The button to use the airphone buzzers and “Y” doorbell are too high. Most interior and exterior door operating forces and closing speeds exceed that allowed. Protruding objects exist in hallways, the gymnasium and in the cafetorium. The running slope of the ramp to the cafetorium stage exceeds the maximum of 8.3%. The book bins and rolls of paper in the hallway on the second floor restricts the clear width on either side to far less than that required. Staff sinks in the main office, staff dining area, and teacher planning rooms lack knee clearance. The kitchen area itself has elements of non-compliance (reach ranges, knee clearances, clear widths) but most of the activities undertaken require personnel who must meet certain physical requirements which a person with a mobility limiting disability would not be able to perform. Therefore no further action is required at the present time unless dictated by a request for a reasonable accommodation. Classroom sinks have water bubblers which are too high and set too far back from the front edge. Some of the classrooms have items placed in the classroom reducing accessible route clear widths and some classrooms have unsecured rugs over the original flooring creating a tripping hazard. Typically the desks and tables throughout the school did meet knee clearance and table/desk top height requirements, but in those instances where they did not, the tables/desks could be adjusted and raised as needed. The adult and student bathrooms were generally compliant with exception to some required height adjustments (grab bars, toilet paper dispensers, mirrors, etc.) as well as some other minor items.

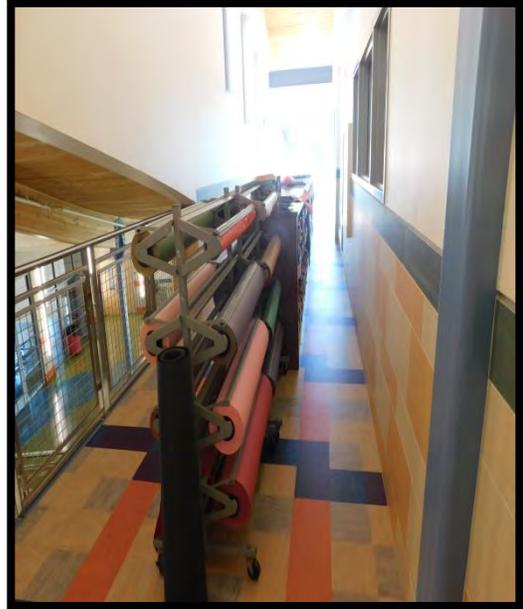
Photo 6 Plains

<p>Level 2 Hallway</p> <p>A portion of the level 2 hallway is used to store construction paper rolls and class room booklets. As a result the accessible route and clear width is reduced to 26" to 28" on one side.</p> <p>See Photo Plains 6.</p>	403.5	20.3	<p>Option 1: Remove items from hallway.</p> <p>Option 2: Eliminate access on one side by placing booklet storage bins and construction paper holder against wall.</p> <p>Option 3 (Recommended): Leave as is and address as needed as a request for a reasonable accommodation.</p>	4	1	L	\$0
<p>Administration, Staff Dining, and Teacher Planning Sinks and Counters</p> <p>The counters/sink in the administration office, teacher planning rooms and staff dining room (#131, #136, #210, #208, #218) lack knee clearance under the sink. Reach ranges for the soap and towel dispensers are too high for a forward reach but within range for a side reach. Two of the rooms (#131, #210) have stoves with non-compliant knobs which are not on the front of the stove. See Photo Plains 7.</p>	306 804.6	32.7 32.8	521 CMR does not govern employee work spaces whereas the 2010 ADA standards does. As these spaces are not open to the public, it is recommended that the stoves be replaced in compliance w/804.6 and 32.8 where cost feasible or as may be required as a reasonable accommodation. Similarly, the sinks and base cabinets should be modified to provide adequate knee and toe clearance per 306 and 32.7 as cost feasible or as may be required as a reasonable accommodation.	-	-	-	NA

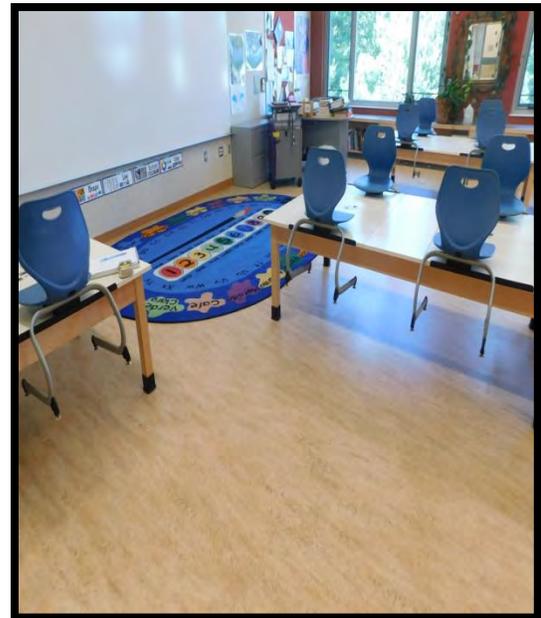
Photo 12 Plains

<p>Art Room (#215) The floor rug is unsecured and serves as a tripping hazard.</p> <p>The art room tables (non- adjustable) provide only 18" of knee clearance.</p> <p>The adult sink lacks knee clearance.</p> <p>See Photo Plains 12.</p>	<p>302.2 902.4 306.3</p>	<p>29.3 35.5 35.6 32.7</p>	<p>Secure or remove rug.</p> <p>Block an existing table or provide a new one with at least 24" knee clearance.</p> <p>Modify sink base to provide adequate knee clearance (27") as part of a reasonable accommodation as may be required.</p>	<p>4 2 2</p>	<p>1 2 3</p>	<p>I N -</p>	<p>\$25 Up to \$150 TBD</p>

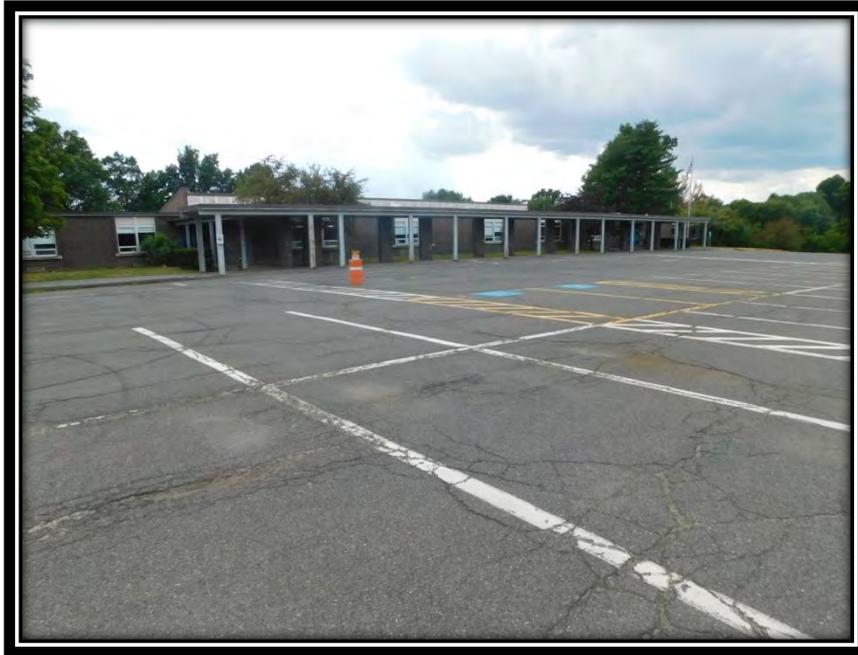
MOSIER ELEMENTARY SCHOOL

General Description or Obstacle Which Limits Mobility or Access: There are numerous areas of non-compliance at the Mosier Elementary School. Parking. The asphalt of the designated accessible parking spaces is deteriorated and cracked. The spaces lack signage with none designated as van accessible. Two of the spaces have non-compliant running and cross slopes. The access aisles for the spaces closest to the basketball court are only 4' wide. Exterior and interior doors have excessive operating forces and closing speeds. Nearly all interior doors have knob-style hardware and lack tactile accessible signage on the operating side of the door. The glass panes on the hallway doors are too high. Typically switches, controls, and phones were at non-compliant heights. Fire alarms, fire pulls, dispensers, and a defibrillator in locations throughout the school serve as protruding objects. Both the adult and student bathrooms have numerous items of non-compliance including reach range, setbacks, clearances, maneuverability, and heights. In some instances items are missing (stall door pulls, grab bar) or an adult standard was applied to a student bathroom. A number of classroom bathrooms also lack the minimum required clear width at the door entrance to the bathroom. The library service counter is too high. Coat hooks throughout the hallways are too high. There is no vertical access to the cafeteria stage as the existing lift was put out of service by the Commonwealth of Massachusetts and is currently blocked by supplies and equipment. The stage stairs lack compliant railings. A number of doorway thresholds exceed that allowed for a change in level surface at a doorway. Some drinking fountains lack knee clearance and exceed maximum height allowance. Classrooms with sinks often did not meet the required knee clearance. Some of these sinks had water bubblers, all of which exceeded height and rim set back requirements. The egress stairs for the modular classrooms have non-compliant railings and are generally unsafe. The ramp to the modular classrooms has a top railing that is not oval or circular and is too low; has a deteriorated ramp surface that is not even; and a ramp that exceeds the maximum

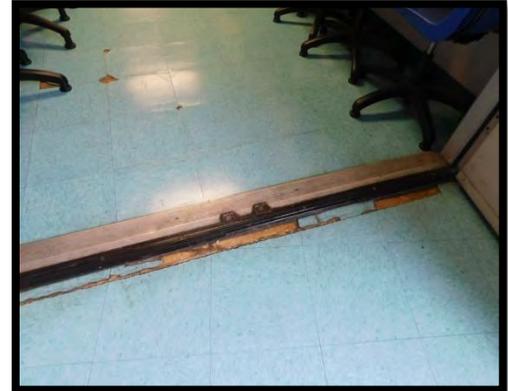
Photo Mosier 12

<p>Abrupt Changes in Level Surface</p> <p>There is an abrupt change in level surface of approximately 1" at the 2nd set of hallway doors to the modular classrooms and to the office off room #127.</p> <p>See Photo Mosier 12.</p>	<p>404.2</p>	<p>26.10</p>	<p>Modify the thresholds so that there is no greater than a ½" change in level surface and is beveled at a height of ¼" to ½".</p>	<p>2</p>	<p>2</p>	<p>I</p>	<p>Up to \$200</p>
<p>Rugs and Carpeting</p> <p>Rugs are unsecured and frayed and carpeting is loose and stretched in the following areas and serve as a tripping hazard:</p> <p>Rugs - Rooms # 110, 103, 104 (2), and 105.</p> <p>Carpeting – Modular classrooms.</p> <p>See Photos Mosier 13 and 14.</p>	<p>302.2</p>	<p>29.3</p>	<p>Secure or remove rugs. Re-stretch and secure carpeting.</p>	<p>4</p>	<p>2</p>	<p>I</p>	<p>Up to \$250</p>
<p>Hallway Coat Hooks (Main & Modular)</p> <p>Hallway student coat hooks are 54" to 55" a.f.f.</p>	<p>308</p>	<p>NA</p>	<p>Lower at least 5% of the coat hooks at each location to a height of no more than 40" a.f.f. under the 2010 ADA Standards.</p>	<p>4</p>	<p>2</p>	<p>I</p>	<p>\$0</p>

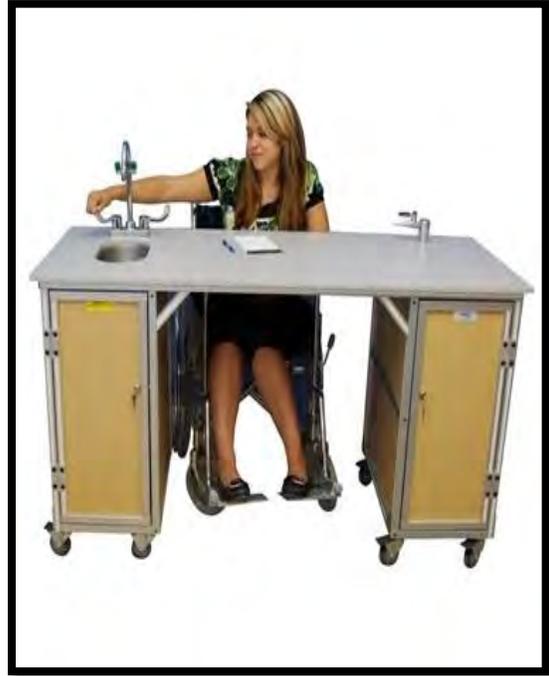
Photo MES 18 ADA Accessible Portable Science Lab
